Northeast Texas Municipal Water District Cypress Creek Basin Highlights Report

An Overview of Bacteria in Big Cypress Creek
below Lake Bob Sandlin and Recreational Use
Attainability Analysis

Assessment of Contact Recreation Use Impairments and Watershed Planning for Big Cypress Creek and Tributaries

TSSWCB Project #09-54

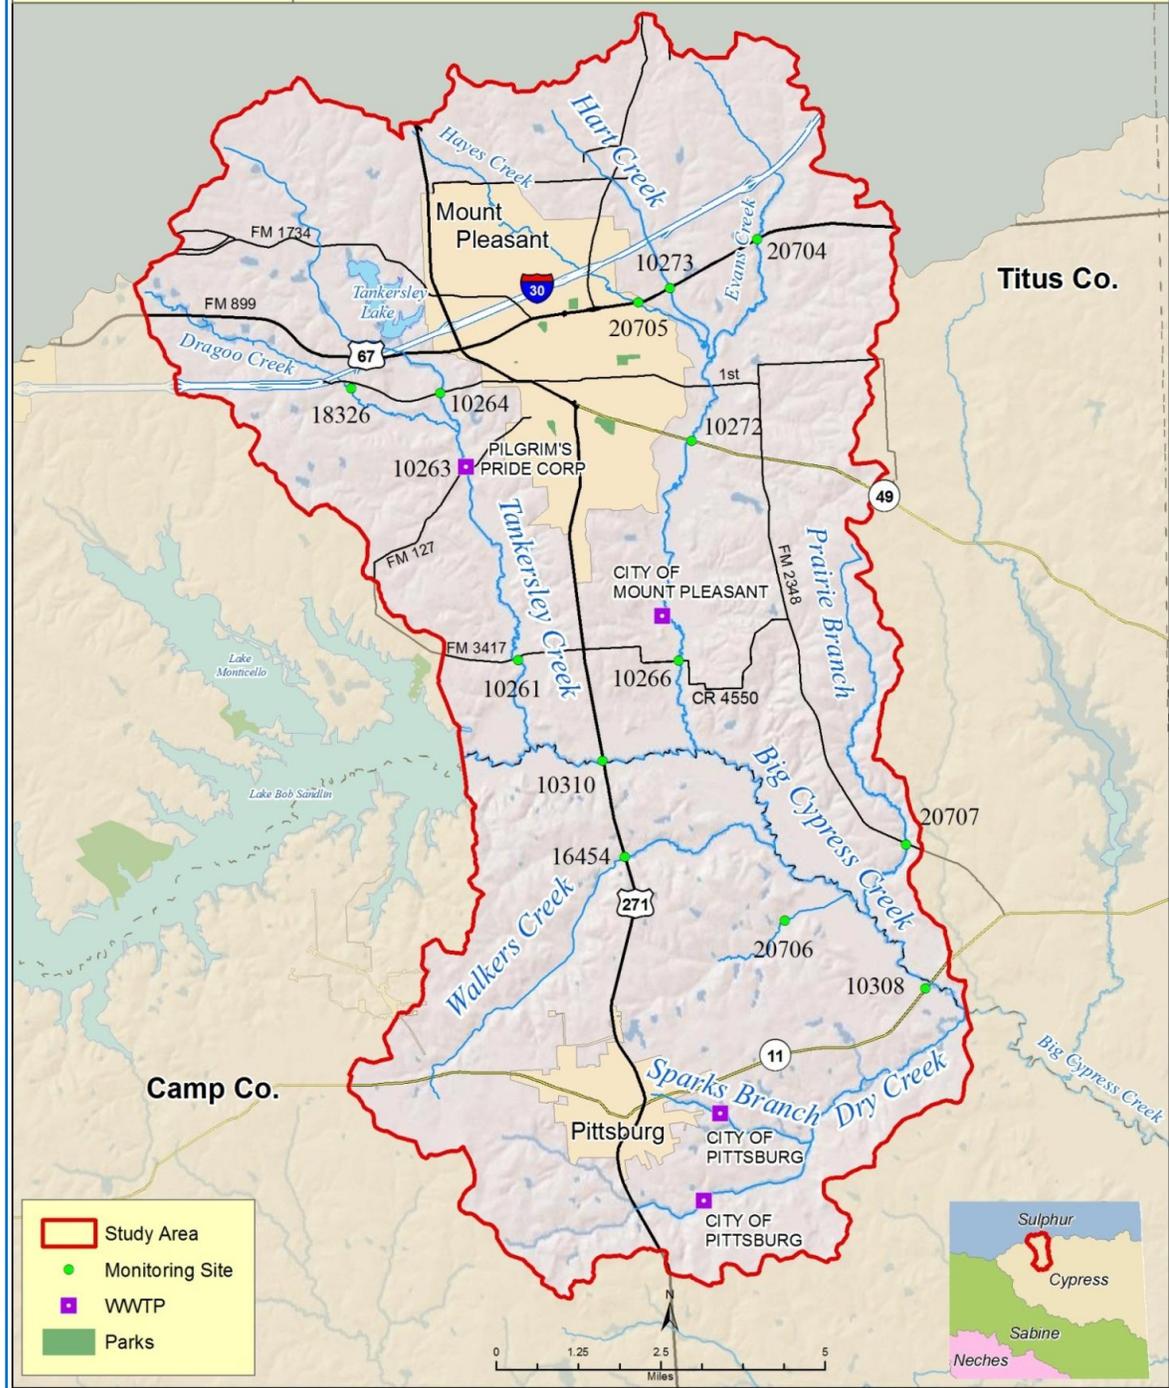
Figure 2: Project Monitoring Stations

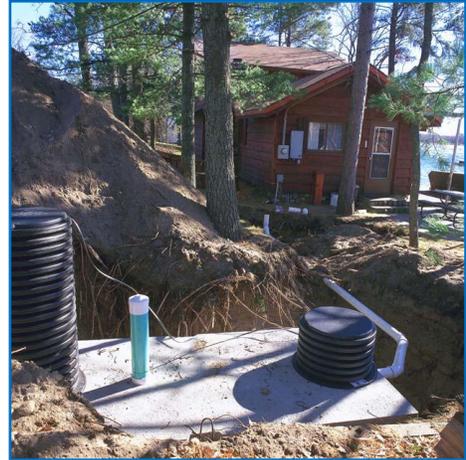
Figure 4: Septic system installation

On-site septic facilities are a common method of wastewater treatment, and it was estimated that 6,182 households were on septic systems in the study area. (McKee, et al., 2011) They can offer a decentralized, lower cost, long-term solution to wastewater treatment as opposed to conventional gravity sewers for large centralized wastewater systems. (Figure 4) However, they require regular maintenance and management to prevent contamination to ground and surface waters. Septic systems that are not installed or maintained properly can fail or leak, and over time, pretreated waste can leach underground and potentially increase bacteria levels in streams. Preliminary BST data showed about 5% of the *E. coli* loading came from human sources. (Martin and Gentry, 2011)

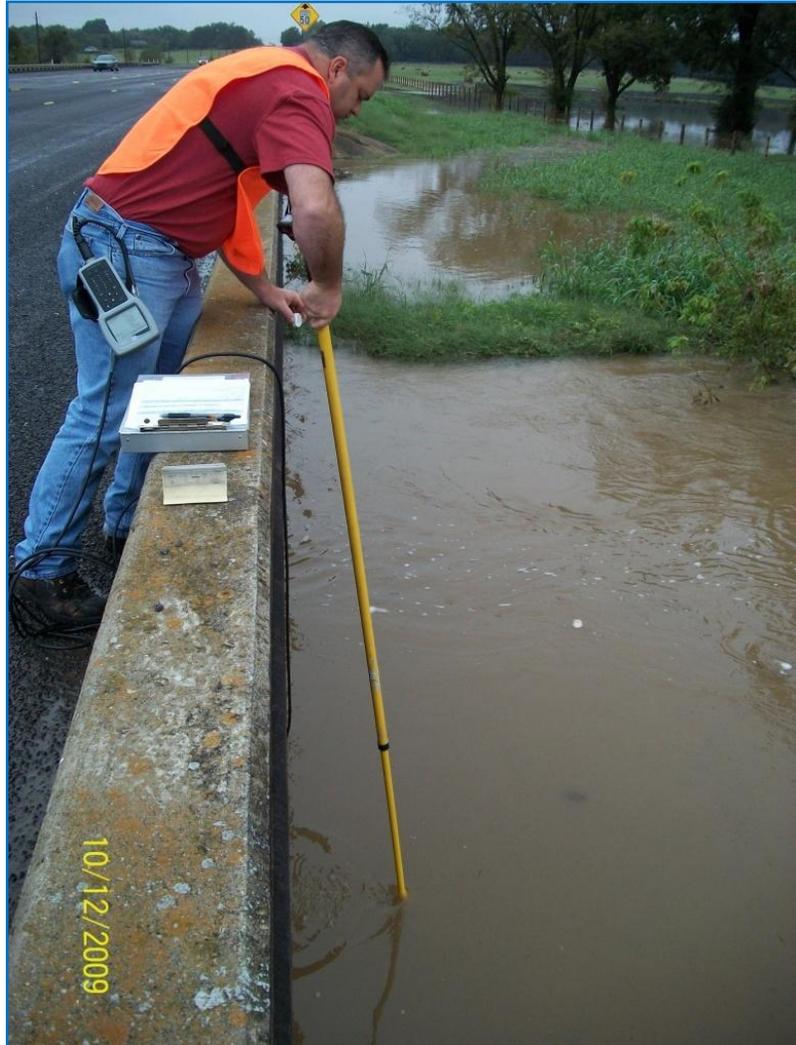
Figure 7: Sample collection by NETMWD staff

NETMWD collected routine ambient samples at fourteen stream sites and at two WWTP outfalls every two weeks from August 2009 through May 2011. (Figure 7) Routine sampling was conducted on a schedule determined by NETMWD and approved in the Quality Assurance Project Plan. Sampling occurred on a temporal basis regardless of conditions and rainfall. Routine monitoring was sometimes interrupted in order to collect storm event samples.

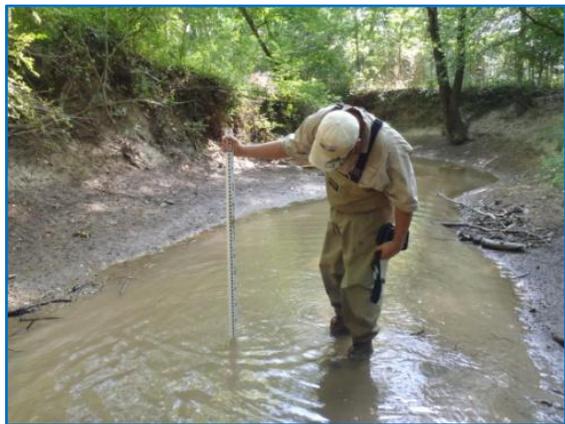
Figure 8: WMS staff measuring thalweg depth

A 300 meter reach was surveyed at each station. The stream width and thalweg depth was measured at 30 meter intervals. Depth was measured using a metric leveling rod and the location of each 30 meter transect was determined using a laser range finder. (Figure 8) A kayak was used to travel and survey the reach at non-wadeable stations.

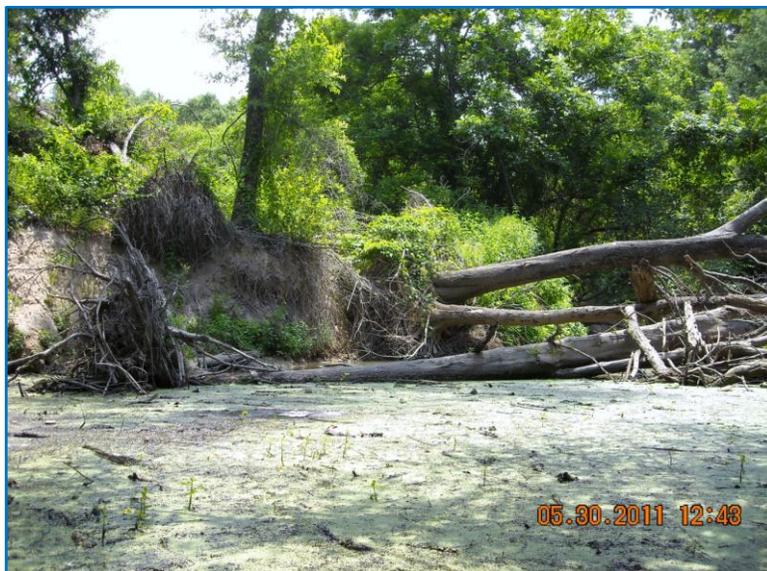
Figure 9: Fallen trees and surface scum in Big Cypress Creek at US 271

Other observations included noting channel obstructions such as dams, log jams, pipelines, fencing and trash; human presence including litter, walkways, fire pits and fishing tackle; animal presence including tracks, trails, nests, scat, and beaver dams (Figure 9) Physical characteristics of the reach such as bank steepness, bank stability, sediment material, water clarity, and vegetation were noted. The ease of access, fencing and/or no trespassing signs, and the number of people present were also recorded on field forms.

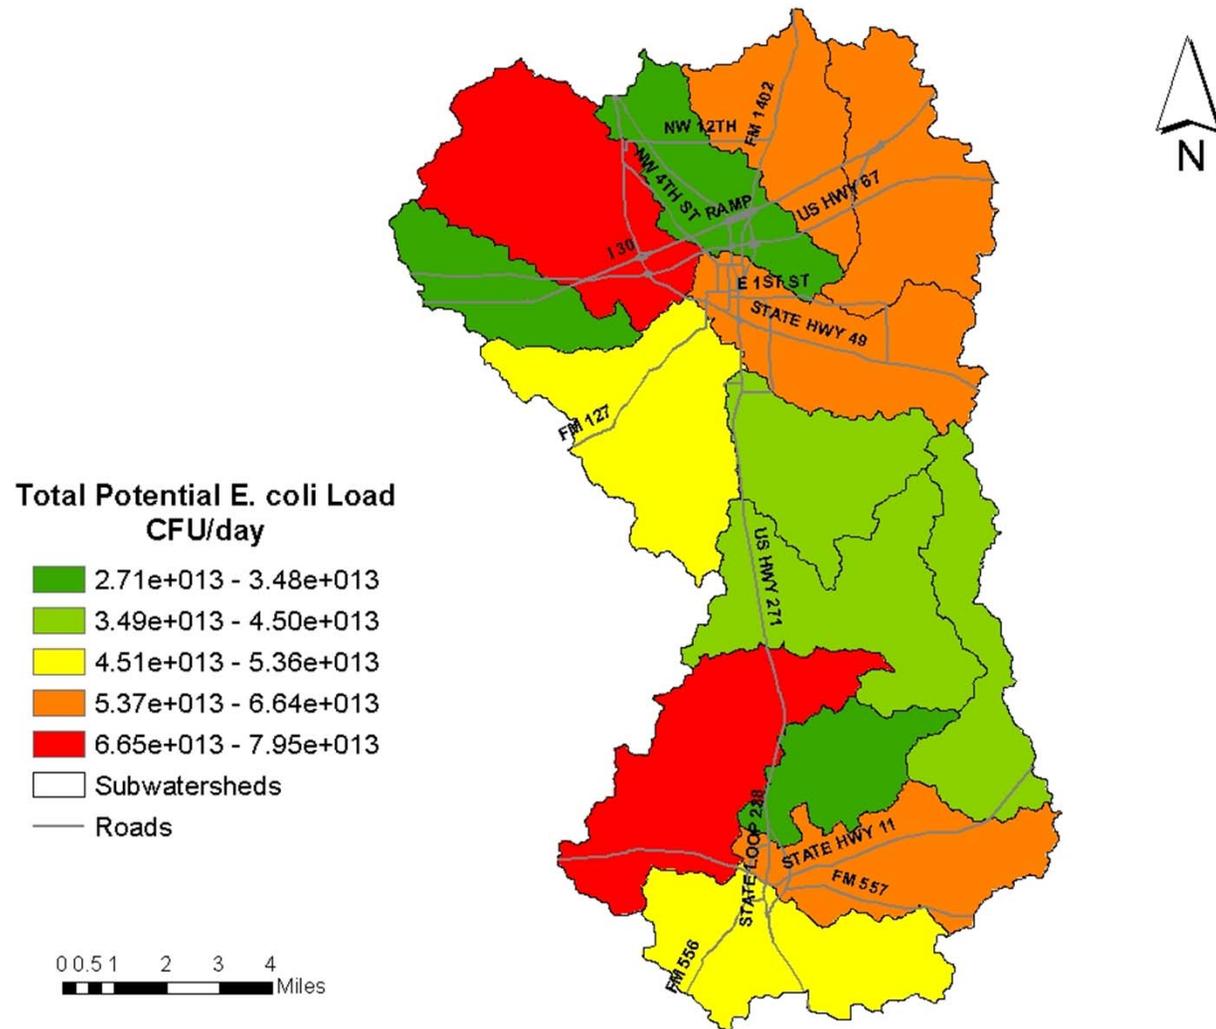
Daily Total Potential *E. coli* load
